Damage reduction countermeasures for short span bridges focusing on restorability of structural joints

Abstract: Lying on one of the world's most active seismic faults, Japan faces the continuous threat of natural disasters. The earthquake that struck east Japan on 11 March 2011, and the devastating tsunami, raised many very serious questions about this country's land and its disaster prevention and disaster reduction strategies for resilience. Disaster-related losses cause short- as well as long-term adverse effects on economy, society, health, culture and the environment. In Japan, the events of 11 March 2011 highlighted the need for the related government agencies, municipalities, research organisations and universities to work together in formulating and implementing a holistic and comprehensive policy approach for damage reduction countermeasures. In this paper, damage reduction countermeasures for short span bridges are presented focusing on the restorability of structural joints, with a view to earthquakes, tsunamis, floods, and deterioration.

Reference to this paper should be made as follows: Yoda, T. and Lin, W. (2021) 'Damage reduction countermeasures for short span bri

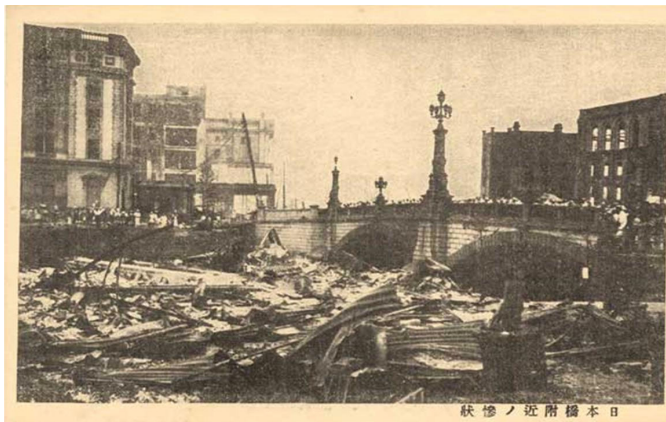
Figure 1 The Kanto earthquake (1923) (see online version for colours)

The typical example of earthquake occurred in Japan was the Kanto earthquake in 1923. The main cause of many casualties in the earthquake was reported as the fire of densely populated area and about 90% of the casualties were resulted from it. The Kanto earthquake initiated the provision of seismic design in Japan. Many steel bridges instead of timber bridges have been constructed after the Kanto earthquake in Tokyo metropolitan area. In these 90 years, we have experienced a number of earthquakes, which yielded pertinent revisions of seismic design in Japan.

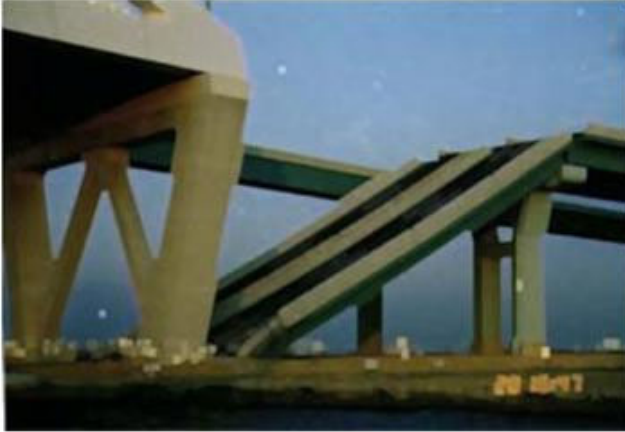
Figure 2 The Hyogo-ken Nanbu earthquake (1995) (see online version for colours)

Girders were fallen in many bridges due to malfunction of unseating prevention devices associated with the collapse of substructures. Accordingly the Japanese specifications were revised to performance-based design methodology.

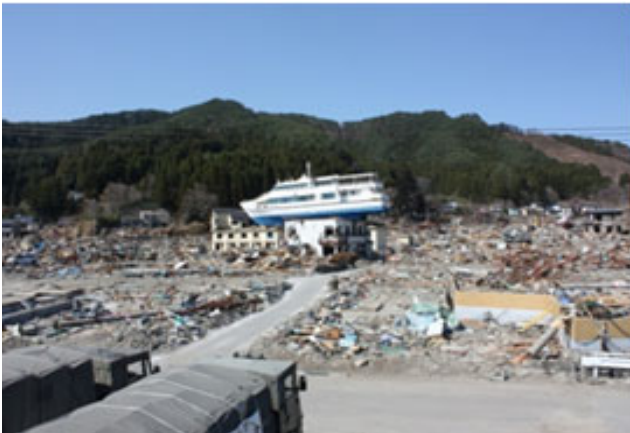
Figure 3 The 2011 off the Pacific coast of Tohoku earthquake (see online version for colours)

The 2011 off the Pacific coast of Tohoku earthquake occurred on the 11th of March in 2011. Powerful tsunami waves were caused by this earthquake and destroyed the cities in coastal area of Tohoku region. The main cause of many casualties in the earthquake was reported as tsunami and about 90% of the casualties were resulted from it.

In the area whose seismic intensity was large, many bridges without damage could be found. This is due to the continuous amelioration of seismic design criteria in Japan.

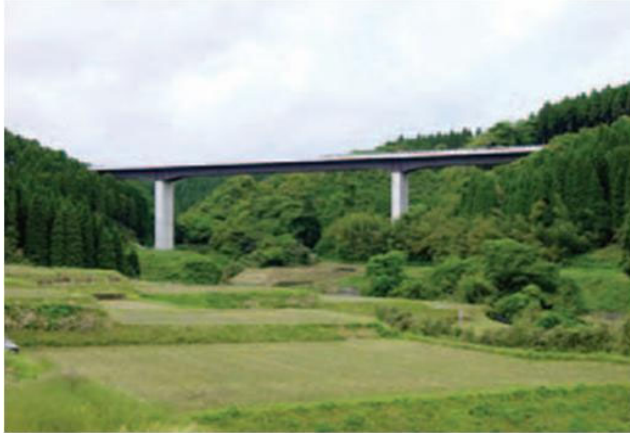
Figure 4 Hybrid rigid frame bridge (see online version for colours)

Even if we shall confine damage reduction countermeasures in the field of bridges, there are a lot of countermeasures to enhance the potential of earthquake resistant capacity. Rigidly-connected girders and piers are examples to make bridge structures earthquake-resistant, as shown in Figure 4 (Japan Bridge Association, 2012). In this paper, in view of resilience, restorable rigid frame joints are proposed in order to keep the rigid frame restorable.

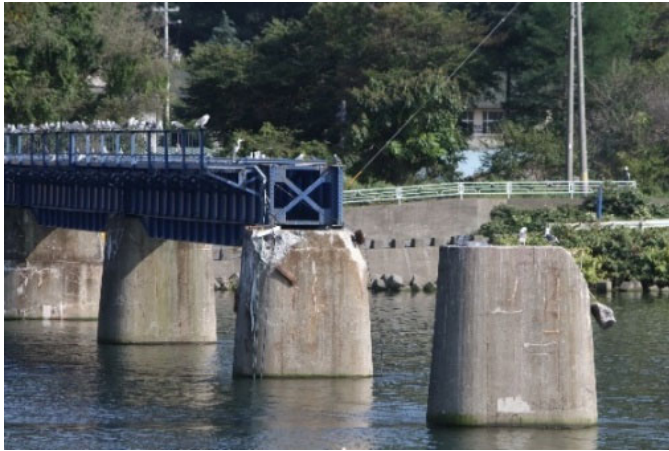
Figure 9 Bridge partially swept away (see online version for colours)

Bridge superstructures were swept away as shown in Figure 9, caused by the 2011 off the Pacific coast of Tohoku earthquake. And some bridges became deformed by collision such as floating ships on tsunami (Figure 10).

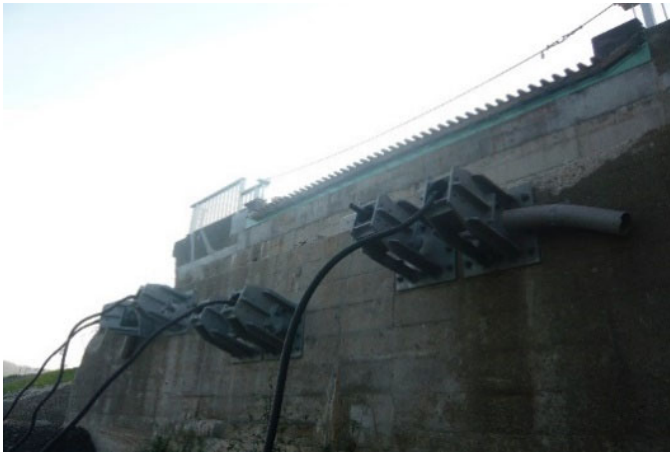
Figure 11 Tearing off of fall-off prevention devices (see online version for colours)

Fall-off prevention devices for steel bridges tore off by tsunami waves. The wave force of tsunami could easily tear off the connectors of fall-off prevention devices which are strong enough to carry the dead load of the bridge itself. Therefore, the fall-off prevention devices are almost useless to prevent the bridge from being washed away by the large tsunami waves. Furthermore, the floating debris could give additional impact load on the superstructure located near the surface of the tsunami waves under the actual condition (Kasano et al., 2012).

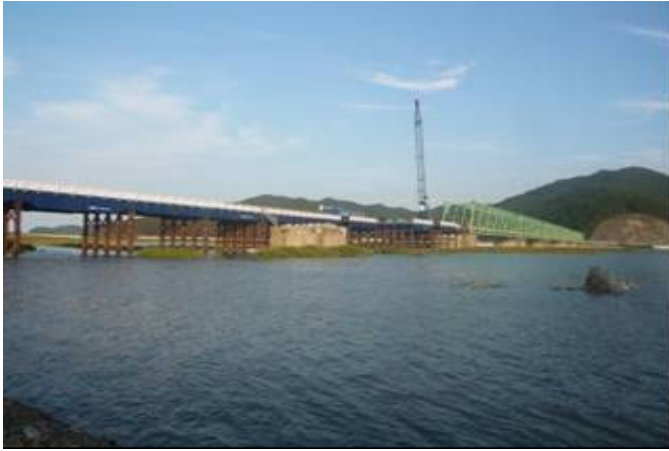
Figure 12 Shin-kitakami Oohashi (see online version for colours)

In view of the height of bridge superstructures, the bridge superstructures that were located in lower height from the ground level tend to withstand the tsunami waves. On the contrary, the bridge superstructures on the high piers are likely to be washed away when subjected to the tsunami waves.

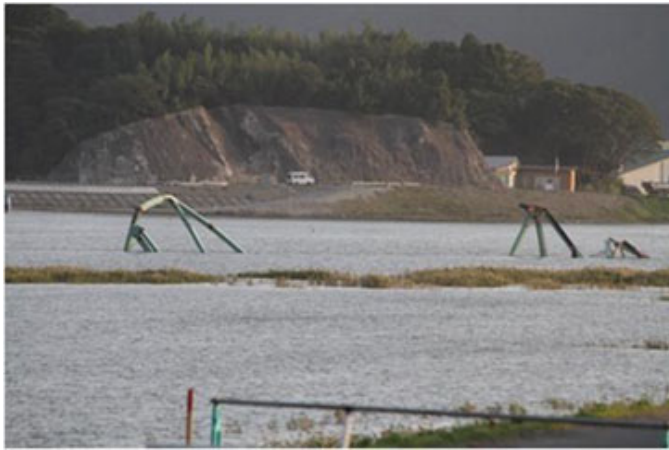
**Figure 13** Truss members being swept away (see online version for colours)

The phenomenon that the bridge superstructures with high clearance tends to be swept away by tsunami waves is opposite to the result brought by the equation currently used to estimate the wave force in Japan. Therefore, in order to confirm this phenomenon, the tsunami wave forces acting on a bridge deck should be examined. Some fundamental studies on the tsunami wave forces acting on a bridge have started since the 2004 Indian Ocean earthquake and tsunami (Murakami et al., 2009; Kataoka et al., 2006; Shoji et al., 2009). Generally the removal of a bridge deck is caused by the lateral wave force in conjunction with vertical force (Araki et al., 2010). However the detailed flow mechanism of tsunami waves has not been explained yet. It is an urgent issue to establish the tsunami force in the design of bridges (Maruyama et al., 2012). More than that, tsunami waves also carried debris including ships on their surface. Then, it is expected that the debris collided with a bridge superstructure and pushed it away. Therefore, if the bridge deck is located as high as the height of tsunami waves, the deck is subjected to not only the wave force but also the impact force of crashing debris (Iemura et al., 2005).

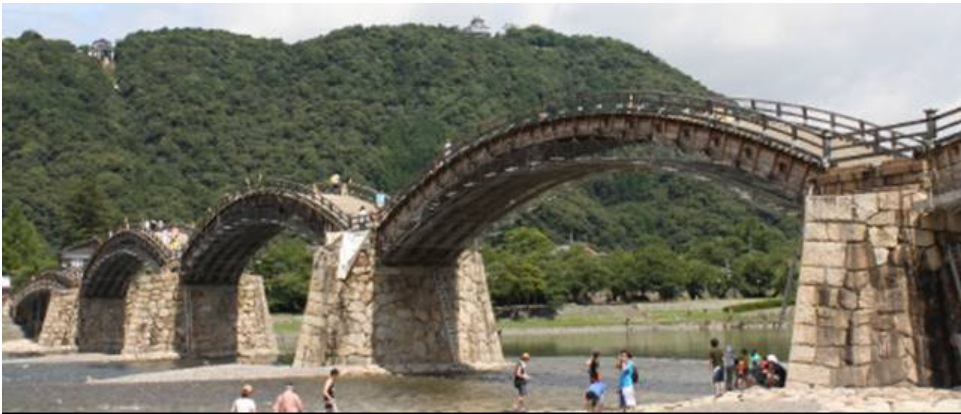
Figure 14 Kintaikyo Bridge as of 2009 (see online version for colours)

The Kintaikyo Bridge over the Nishiki River at Iwakuni in Japan was originally constructed in 1673. The five-span wooden arch bridge is one of the most historically significant bridges not only in Japan but also in the world (Figure 14). Each span of the three central arches is 35.10 m, the total length being 193.3 m and the roadway being 5.0 m wide. Despite the bridge's unique five-span arch structure, which is designed to enhance durability, the bridge is vulnerable to natural disasters such as floods and earthquakes.

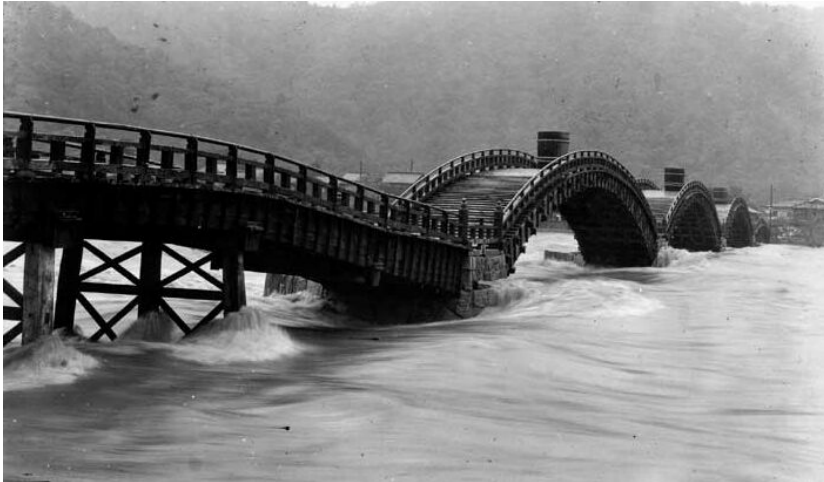
Figure 15 Loss of one pier before collapse (1950)

The Kintaikyo Bridge was washed away on 14 September 1950 (Figure 15), when the river's flow volume increased to 3,700 m³ per second at the point of the bridge. This flow volume exceeded the bridge's designed flood control level of approximately 2,470 m³ per second.

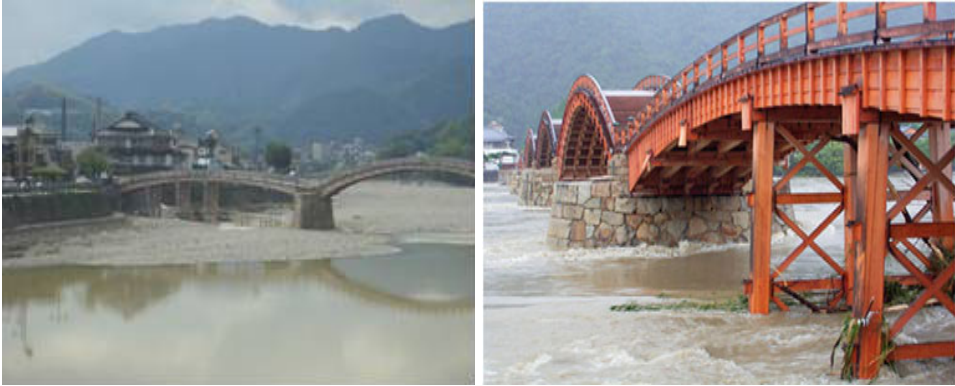
Figure 16 Loss of two piers reducing damages (2005) (see online version for colours)

Despite the loss of the two piers from the first span, its superstructure remained intact (Figure 16). The superstructure was protected by the design of a special tenon called *hozo* which had been tapered to allow members disjoint easily, so that substructural damage would not impact the superstructure. In other words, the *hozo* was designed to function in a way similar to a fuse in an electric circuit and used to prevent damage to expensive or difficult to repair the superstructure. This unique damage reduction countermeasure is considered to be based on the fail-safe design concept which could manage the mitigating damage if failure occurs.

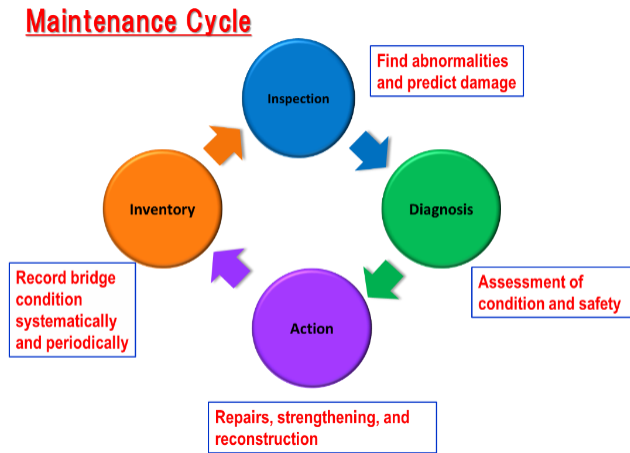
Figure 18 Maintenance cycle of bridges (see online version for colours)

As to maintenance technology, new techniques need to be adequately evaluated and an arrangement and contract system to promote their use are required. Advancements in non-destructive inspections are remarkable; therefore, it is indispensable to promote the streamlining of standards and systems based on latest technologies and inspection data (RAIMS, 2019). Requirements for the amelioration of resilient systems are often said to be the ability of anticipating, monitoring, responding, learning (including AI). These requirements are directly related with inspection, diagnosis, action, inventory, in the maintenance cycle (Figure 18).
