Seismic vulnerability assessment of churches at regional scale after the 2009 L'Aquila earthquake

Keywords: seismic vulnerability; cultural heritage; old churches; structural damage; fragility curves.

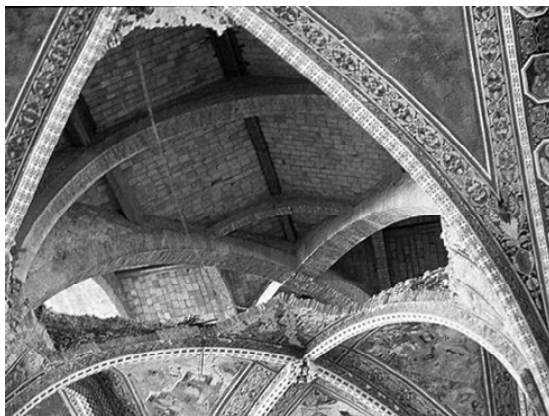
Figure 1 St. Francesco d'Assisi basilica

Note: Damages on the vault after the 1997 earthquake.

A meaningful example of how important is to protect churches from earthquake attacks is given by the partial collapses of the St. Francesco d'Assisi (PG) central vault (Umbria e Marche earthquake, 1997), shown in Figure 1, which caused not only human fatalities, but also losses of important and valuable frescoes.

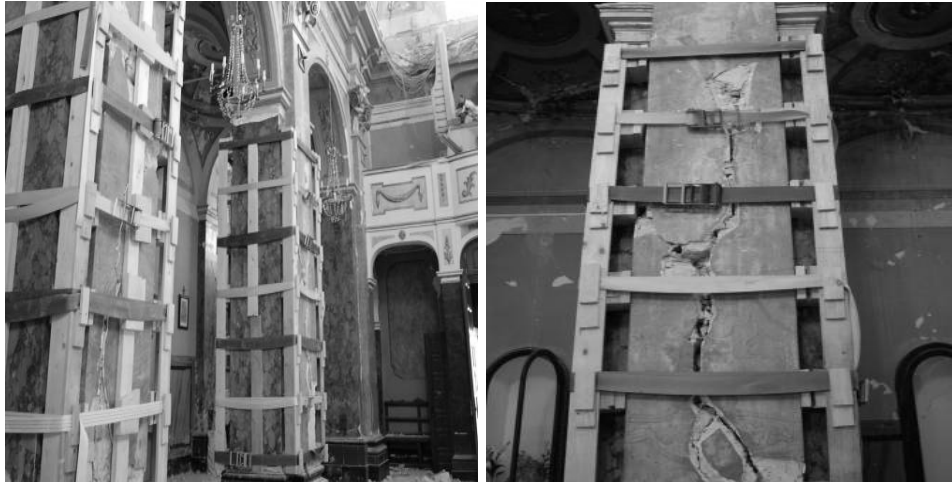
Figure 7 Observed damages after the 2009 seismic event on rubble masonry pillars of St. Gemma (SGM) church in Goriano Sicoli (AQ)

In pillars, vertical cracks due to crushing phenomena have been sometimes relieved. These have been probably induced by the increasing compression stresses, due to the earthquake vertical component, which, even far from the epicentre, was often significant due to site effects (De Matteis et al., 2016b). The above failures are particularly evident

on those columns made of rubble masonry (typical of *post-medieval* and *hybrid* churches), where cracks along the mortar have been observed (Figure 7).

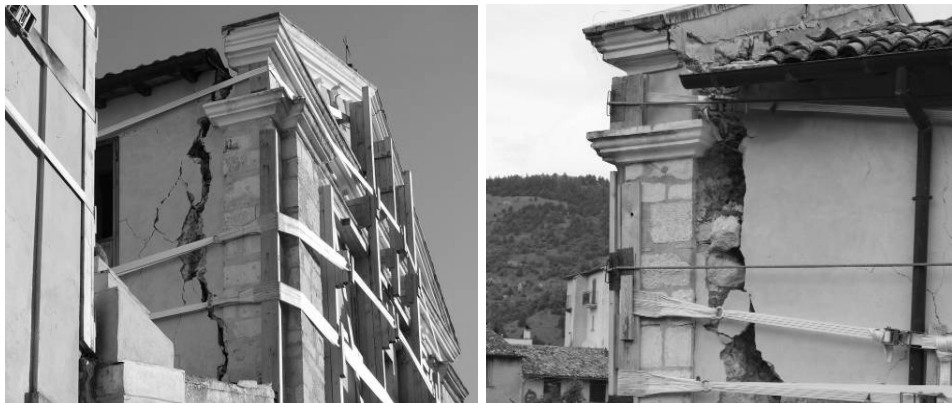
Figure 8 Façade overturning in SGM church in Goriano Sicoli (AQ)

A heavy damage has been observed on churches where reinforced concrete roof or beams have been added in recent years without effective connection with the vertical walls. The presence of these elements is evident in those churches affected by horizontal sliding cracks at the ring beams at the top of the walls. Out-of-plane mechanisms have been identified when macro-elements resulted not correctly endowed with a proper number of well dimensioned ties. For the analysed churches, three main out-of-plane phenomena have been recognised: the rigid façade overturning, the façade top-corner overturning and the apse overturning. The first type of mechanism was evident, for example, in the SGM church in Goriano Sicoli (in the Sulmona-Valva Diocese). This church showed a fully developed mechanism, with a detachment between the façade and the lateral walls of about the thickness (Figure 8). The façade top-corner overturning has been detected

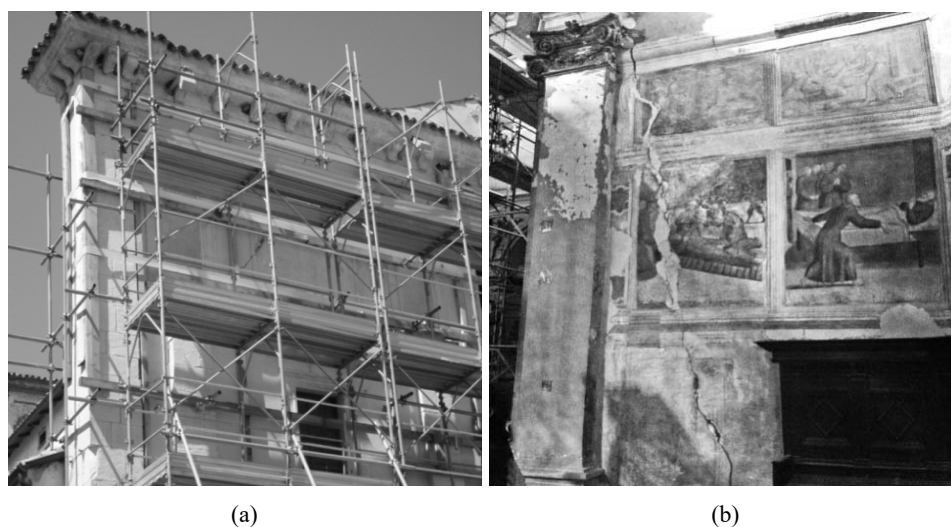
Figure 9 (a) Top-corner overturning on St. Maria della Pace church in Capestrano and (b) apse overturning on SMA church in Gagliano Aterno

when, even in presence of longitudinal ties that effectively constrained the rigid overturning of the whole façade, the corner connection was clearly inefficient due to the lack of restraining element [see Figure 9(a)]. Finally, the third type of overturning mechanism concerned the apse. It was generally due to a bad connection or to the presence of wide openings. A meaningful example is the case of St. Martino (SMA) church in Gagliano Aterno, where the diagonal cracks, typical of this mechanism, have been surveyed [see Figure 9(b)].

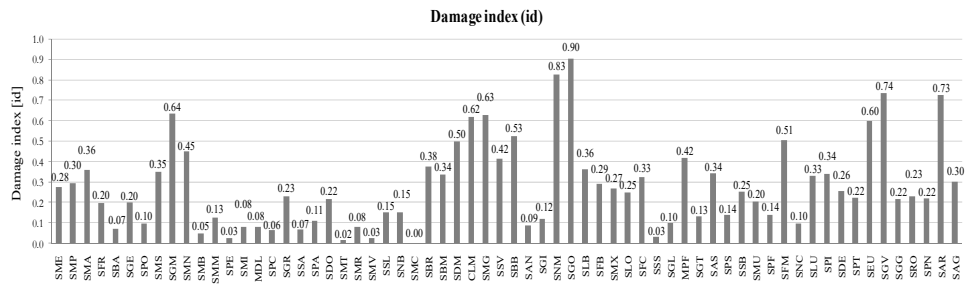
Figure 11 Damage index i_d for all the observed churches

Consistently with the Italian code *Guidelines for Cultural Heritage* (MiBACT, 2011), the classification of the observed damage has been carried out accounting for 28 mechanisms referred to the main macro-elements (i.e., the façade, the colonnade, the vaults, the apse, the transept, the dome and the bell tower). For each mechanism, a specific level of damage d_k ($0 \leq d_k \leq 5$), has been defined according to the criteria introduced by Grunthal for the European Macroseismic Scale EMS-1998 (Grunthal, 1998). In Figure 10, the Grunthal definition of damage levels, proposed for residential buildings, is related to churches, according to the criteria described in De Matteis et al. (2016b). Then, according to equation (1) proposed in guidelines, a global damage index (i_d), ranging from 0 (no damage) to 1 (full damage), has been calculated for each church belonging to the analysed stock. The results are given in Figure 11.

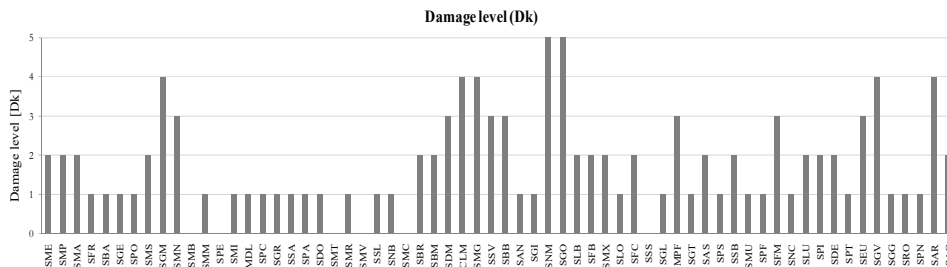
Figure 12 Damage level d_k for all the 64 observed churches

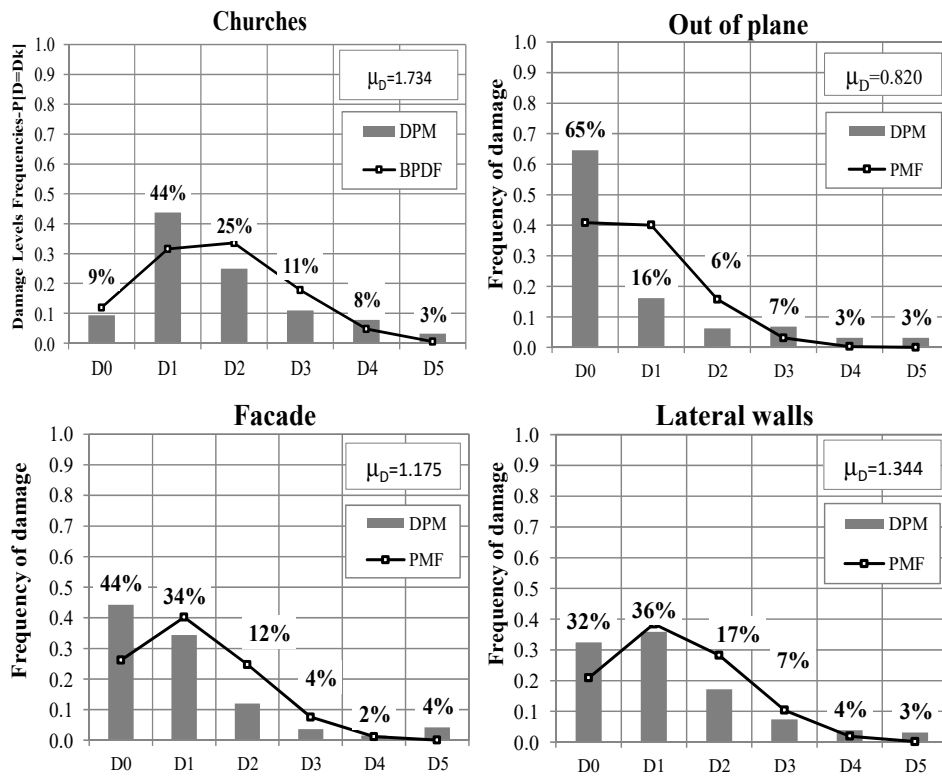
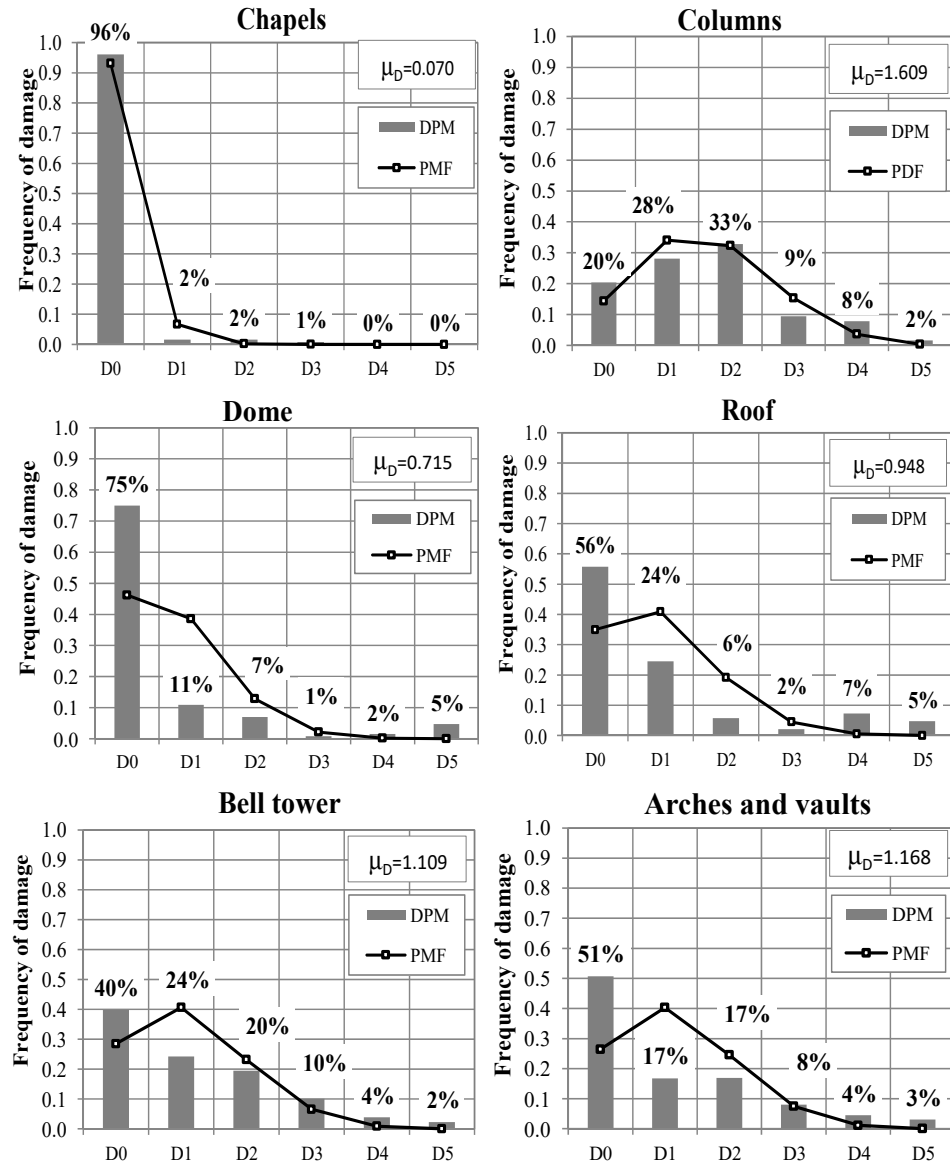
Figure 13 Damage probability matrix of the 64 observed churches vs. binomial distribution

Once the data on damage have been defined, it has been observed that a binomial probability distribution function (BPDF) fits suitably the related DPMs of both the whole churches and the single macro-elements, as shown in Figure 13. In particular, the adopted BPDF is given in equation (2), where p_k represents the probability to have a certain level

It can be observed that the binomial distribution is particularly able to retrieve back the probability of having a certain level of damage for a given earthquake. This is a significant outcome, as the above distribution depends on one parameter only, namely the mean damage μ_d . The latter could be preventively assessed based on the structural fragility of the analysed churches, allowing the application of the above procedure as a predictive tool rather than as an observational analysis.

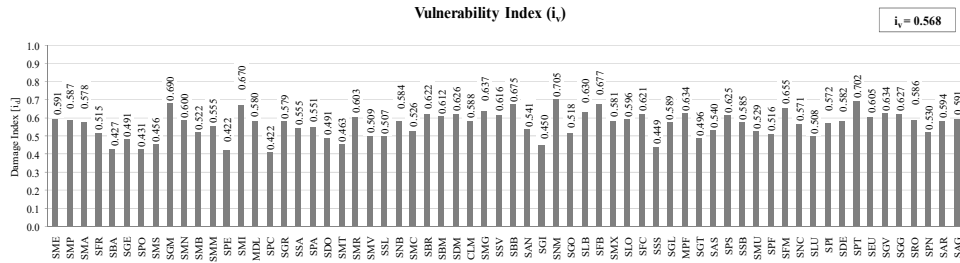
Figure 14 Vulnerability indexes for the 64 churches observed in the Sulmona-Valva and L’Aquila dioceses

In equation (7), ρ_k is the importance factor already provided in equation (1). As a matter of example, in Figure 14, the vulnerability indices of the churches of the two dioceses described in Section 2 are given.

Values ranging between $i_V = 0.422$ (St. Pelino and St. Pietro Celestino churches, in the Sulmona-Valva Diocese) and $i_V = 0.705$ (Ss. Nicandro and Marciano church, in the L'Aquila Diocese) have been founded, with a mean value of the obtained vulnerability indices equal to 0.568.

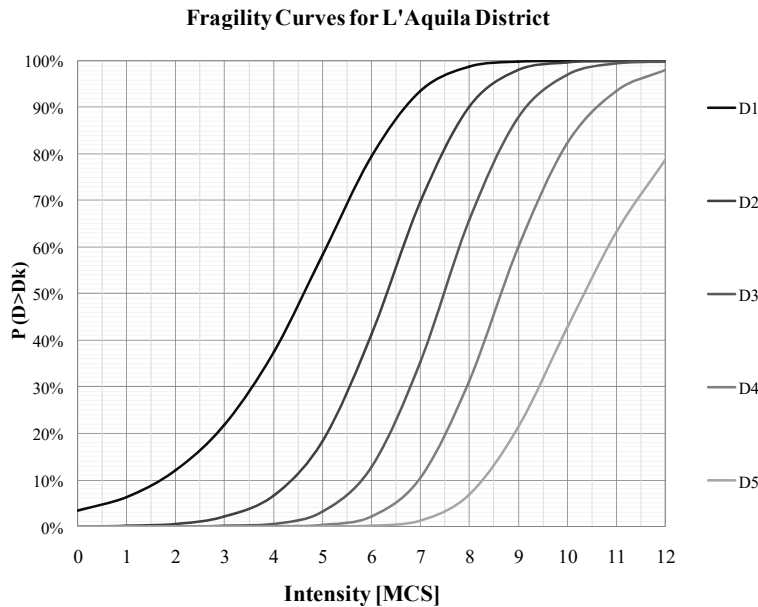
Figure 15 Fragility curves for three nave churches in the Sulmona-Valva and L’Aquila dioceses

The obtained fragility curves are shown in Figure 15. It is clear that the proposed fragility curves may represent a powerful tool to be used for outlining possible mitigation policies based on costs-benefits analyses and on the definition of acceptable risk for different levels of expected hazard. In addition, the proposed methodology allows to appreciate the reduction of seismic risk that can be pursued by applied strategically some retrofitting interventions on a stock of churches that can lead to a reduction of the vulnerability indices and, therefore, of the damage that they could undergo for a given earthquake intensity.

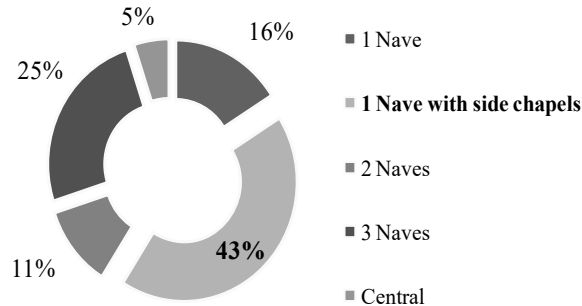
Figure 19 Churches typologies belonging to the Alife-Caiazzo diocese

In this diocese, more than 60 churches have been identified. Among them, about 43% are one nave with lateral chapel churches (Figure 19). Therefore, in such area, differently than in Abruzzi, one nave complex (with lateral chapels) churches seems to be the most interesting typology to be investigated.

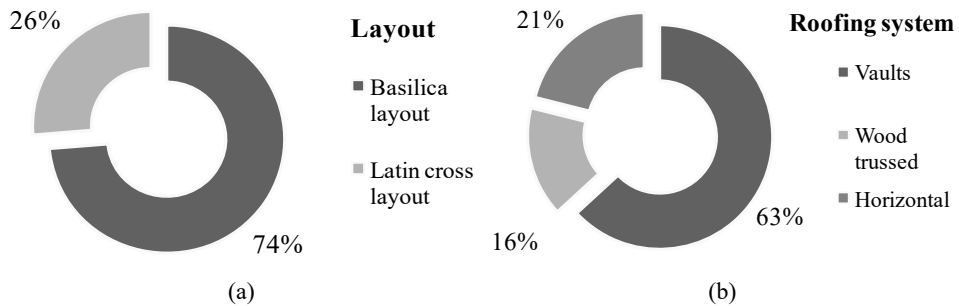
Figure 20 (a) Layout and (b) roofing system for one-nave with lateral chapel churches in the Alife-Caiazzo diocese

For such a church typology, the 74% has a basilica layout, characterised by a rectangular plan, a central nave and the lateral aisles, without transept; the 26% of churches has a Latin cross layout, with a transept crossing the main body. Façades are often characterised by different structural and architectonic features with respect to other macro-elements, as they were usually erected after the construction of the main body of the church. For the same reason, generally, they are not structurally connected to the transversal walls. One of the most frequent façade layouts is the salient façade (47%), which is characterised by a gable roof with tympanum on the central nave and two rakes upon the aisles. Gabled façades have been detected also in the 47% of the surveyed cases. Finally, only the 5% has a horizontal cornice, where the different height of the naves is concealed.

The top of the façade is in the 37% of cases sailing. This appears to be the most vulnerable typology, as the triangular elements at the top of both sides result very prone to develop overturning mechanisms due to the lack of restraining elements. Heavy thrusting (i.e., barrel and cross vaults) are present in the 63% of the analysed cases, whilst light elements (i.e., visible timber truss and flat soffits) can be observed for the 37% of selected churches.
