Resilience and sustainability of FRP-retrofitted concrete structures

Abstract: Damaged, deteriorated and deficient structures can prove to be among the biggest obstructions in an otherwise resilient community. An innovative rehabilitation technique using fibre reinforced polymers (FRPs) was developed to build resilience in such structures. Lab investigations found that deteriorated concrete columns sustained about 20% loss in strength and larger reduction in ductility and energy dissipating capacity as a result of corrosion induced deterioration. Experimental results showed that utilising FRP and special grouts not only recovered but enhanced the mechanical performance of these structures. Long-term testing in the lab and observations in the field found excellent durability in FRP and FRP-retrofitted structures. This innovative repair technique resulted in remarkable reduction in risk of deterioration and performance degradation. It was concluded that resilience can be built into deficient or damaged structures through incorporation of innovative retrofitting techniques and utilisation of durable materials that are economical and superior to traditional methods.

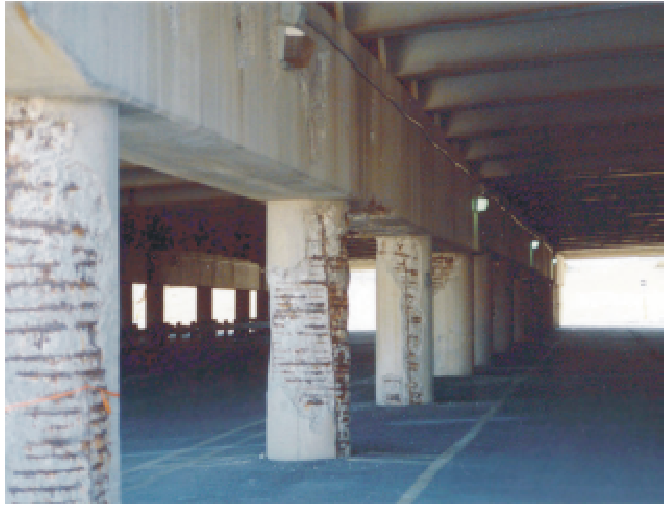
Figure 1 Highway bridge columns deteriorated as a result of steel corrosion (see online version for colours)

In a complex structure, attention needs to be paid to the components that play a vital role in maintaining the integrity of the structure. While the bridge in Figure 1 was damaged due to corrosion after decades of service, many existing structures are deficient as a result of design flaws or outdated design codes. Some members of a structure may have inadequate ductility, sudden failure of which would result in a brittle collapse of the entire structure during a severe earthquake. Research was undertaken at the University of Toronto to address these issues as well as the sustainability of fibre reinforced polymer (FRP) over time when subjected to extreme environments such as freeze-thaw cycles, alkalis and ultraviolet (UV) radiation (Homam, 2005; Sheikh, 2007; Colalillo and Sheikh, 2014; Liu and Sheikh, 2013). Results from the field monitoring and lab research on the durability of FRP are presented in this paper.

In structures such as the one shown in Figure 1, corrosion is often concentrated in the transverse reinforcement. Expansion generated by corrosion products cracks and spalls off the concrete cover that exasperates the rate of steel corrosion and subsequently adversely affects the load carrying capacity as well as ductility of the structure. To evaluate the impact of deterioration, half scale models of the bridge columns, 406 mm in diameter and 1.37 m long, were tested in the lab. Due to the deterioration caused by spiral steel corrosion, the axial load carrying capacity of the columns was reduced to less than 80% of that of the healthy columns. The deformation capacity and ductility of the columns was affected to a much larger extent (Sheikh, 2007).

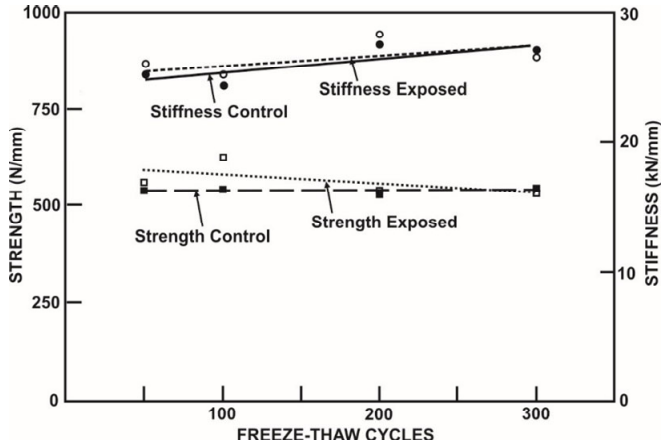
Figure 4 Strength and stiffness of GFRP coupons exposed to freeze-thaw cycles

Figure 4 compares the tensile strength and tensile stiffness of exposed GFRP specimens to their control counterparts after exposure to 50, 100, 200, and 300 cycles of freeze-thaw. The strength and stiffness of GFRP coupons were not found to be significantly affected by exposure to freeze-thaw cycles. The same applies to their strains at rupture. While some researchers (Won and Park, 2006) have reported some adverse effects of freeze-thaw cycles on GFRP strength, others (Karbhari and Engineer, 1996) observed similar results as reported here including a small increase in stiffness of glass composites.

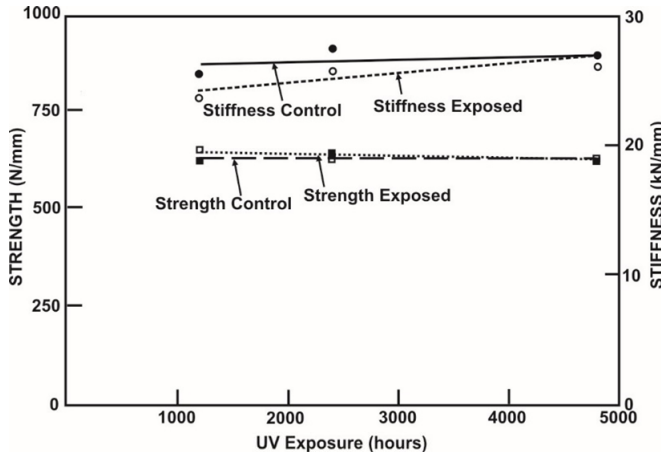
Figure 5 Strength and stiffness of GFRP coupons exposed to UV radiation

Figure 5 compare the tensile strength and tensile stiffness of UV-A exposed GFRP coupons to their control counterparts. On average, the strength of the exposed GFRP coupons remained slightly higher than those of the control specimens for the

three durations (1,200, 2,400 and 4,800 hours) of UV radiation. This increase may be partly attributed to the elevated temperature of the UV chamber (35°C). However, the effects on stiffness varied. Initially, GFRP coupons initially sustained a slight, about 7%, loss of stiffness with respect to the control samples but later recovered as the duration of the exposure increased. The stiffness of the specimens after 4,800 hours of exposure was slightly greater than the stiffness of specimens exposed for 1,200 hours. No major negative effects on the mechanical properties were observed and UV radiation appeared to affect only the surface of FRP.

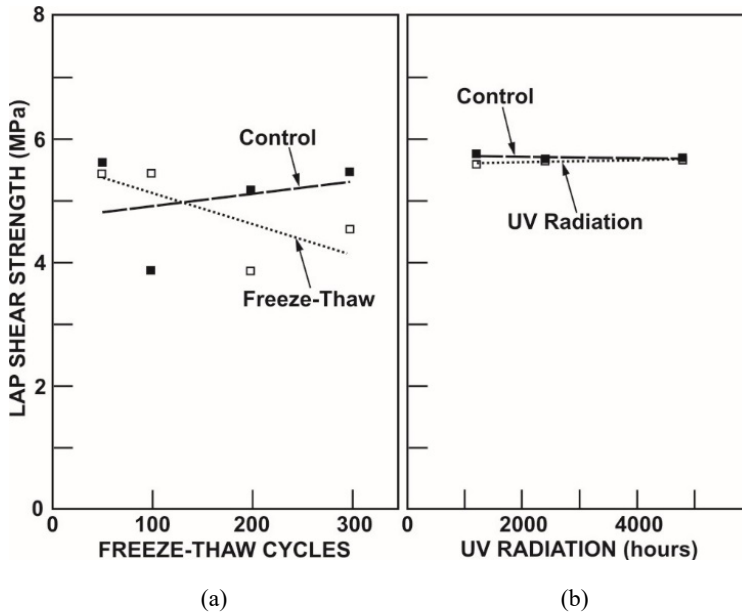
Figure 10 Lap shear strength of GFRP SLB specimens exposed to (a) freeze-thaw cycles and (b) UV-A radiation

Figure 10 presents the variation in the lap shear strength of GFRP specimens as a result of freeze-thaw exposure.

Although, a large scatter in the test data was observed, a clear trend was obvious that the average bond strength of exposed GFRP specimens decreased by as much as 18% after 300 freeze-thaw cycles. Initially, the bond strength stayed constant or increased slightly, but it deteriorated thereafter as the number of freeze-thaw cycles increased. The early strengthening can be attributed to an increase in the cross-linking within the matrix (Karbhari and Engineer, 1996) and the subsequent drop in strength to the damage caused by the formation and propagation of ice crystals within voids at the bonded interface. The weave of the glass fabrics leaves a high percentage of air gaps at the bonded interface which may not be filled with epoxy. However, in hardened resin, these air pockets can get filled with water, especially in submerged specimens, and cause damage at the interface when frozen.

The lap shear strength of GFRP specimens was hardly affected by UV radiation (Figure 10). These results were expected because UV radiation mainly affects exposed surfaces of the fibre material and does not degrade or chemically alter the epoxy at the interface region.

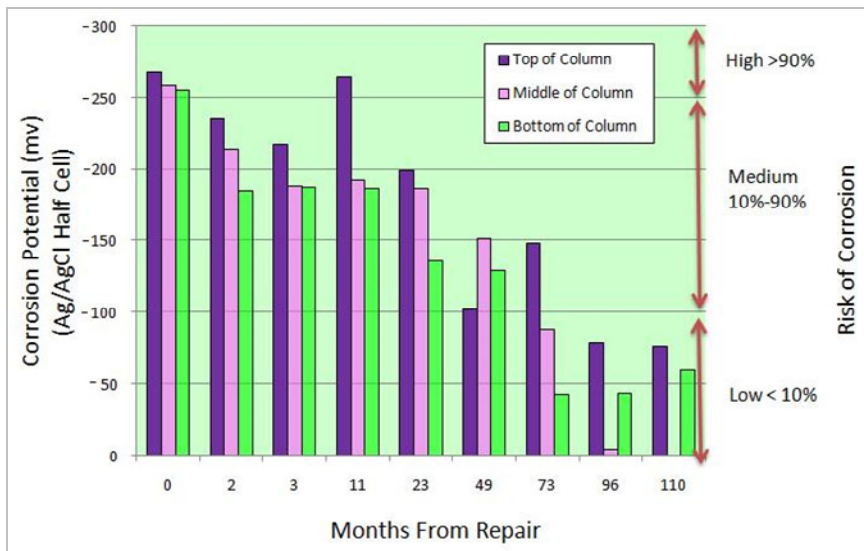
Figure 12 Corrosion activity in repaired bridge column (see online version for colours)

Several columns in the bridge were instrumented to collect strain data from GFRP wraps and to monitor corrosion over time. Field data for up to first 73 months of field monitoring was reported by Sheikh (2007). Beyond that time, corrosion activity continued to be monitored for another 37 months. Figure 12 shows the corrosion potential and risk of corrosion in a field column different location along its height for over 110 months. This data is based on the measurements from half-cells embedded in the columns. At the time of the repair, from the average of potential measurements at three locations, top, middle and bottom, along the height of each column, it was determined that the risk of corrosion in repaired columns was medium or intermediate. Eight years later, the risk of corrosion in all the column was found to be low. Reduction in the corrosion activity and reduced risk of corrosion can be clearly seen for one of the columns, in Figure 12. It is clear that GFRP wraps protected the columns from adverse environmental effects by starving the corrosion of its essential ingredients, water and oxygen, resulting in reduced corrosion activity. The field data corroborated the tests conducted in the lab on small specimens as discussed above. Monitoring of the columns over the years through visual inspection and field data on strain and corrosion rate indicated a sound performance of the retrofit techniques. No distress or deterioration was observed in these columns after about 20 years of service. Field monitoring was terminated when the performance was ensured to be of no further concern.
